BEITRÄGE ZUR GEOLOGIE DER SCHWEIZ
KLEINERE MITTEILUNGEN

**Weathering of Molasse Sandstones
of Monuments and Natural Outcrops**

K. Zehnder

Institut für Denkmalpflege und Institut für Kristallographie und Petrographie, ETH-Zentrum, 8092 Zürich

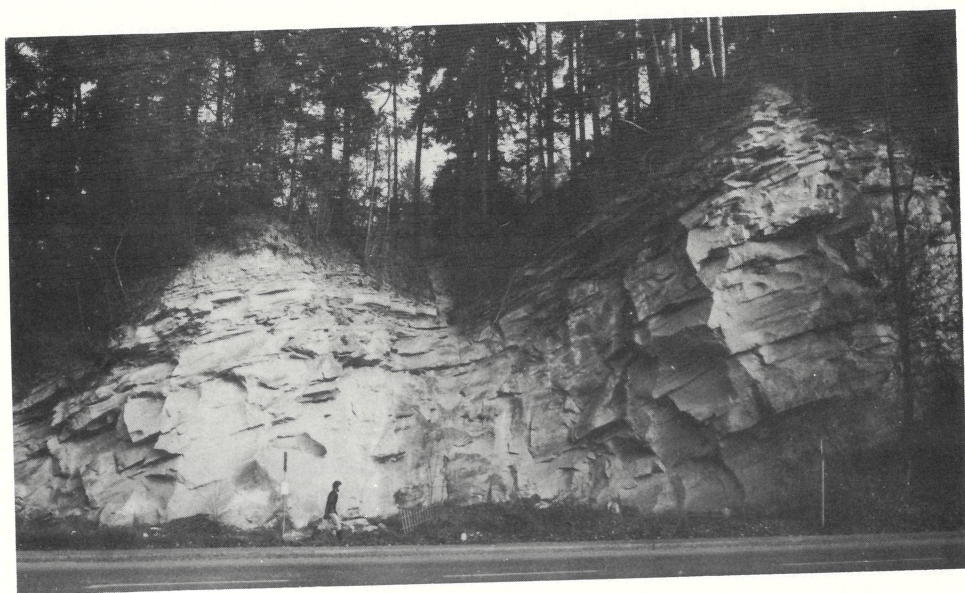
Fig. 5 – The ancient quarry «Martinsbrugg» (near St. Gallen, Eastern Switzerland) in Platten sandstone. a) Part of the quarry viewed from south west. b) Sketch after picture a) figuring the pattern of weathering phenomena on the rock (slightly simplified). *Legend:* 1. Marl beds overlying the quarried sandstone, 2. contour scaling, 3. peeling and granular disaggregation, 4. efflorescences, 5. area wetted by periodical water leakage.

Contour scaling occurs in the centre and to the left (northwest) of the outcrop (figure 5b). The rock surface there is unhurt but covered with algae. A sharp edged date, «1899», chiseled on one place confirms its durability. Scales are about 0.5-2 cm thick. Underneath, a crumbling zone consists of sand, spalls and flakes which are dotted with white gypsum spots towards the surface.

Efflorescences of gypsum form filmy white powdery covers. They concentrate in and immediately below the marl beds (marked in figure 5b) in sheltered areas which are reached periodically by ground waters from the marls. The efflorescences follow in cm to a few dm wide strips the borders of these wetted zones. In contrast to the periodically moving MgSO₄ efflorescences, gypsum efflorescences disappear only when wetted by superficial waters. The exact shape of wet zones may change from one rain period to the next but their rough pattern is stable. MgSO₄ efflorescences form either fluffy white aggregates up to 5 mm thick, or about 1 mm thick rigid sandloaden crusts. In this outcrop, MgSO₄ is the only soluble salt which has been found until now. (With a few exceptions of Na₂SO₄, MgSO₄ is prevailing in the considered natural outcrops on both Granitic sandstones and on Platten sandstones). MgSO₄ efflorescences concentrate besides the periodically wetted zones from the gypsum efflorescences to 0.1-1 m outwards in the sheltered areas. Peeling and granular disaggregation are most efficient in these streaks. In addition, MgSO₄ is spread over the rock surface in the area where peeling is observed, as peeling off sheets hide the soluble salt crystallizing underneath (figure 7). MgSO₄ efflorescences avoid projected edges but favour adjoining recesses, leading to an accentuation of the relief. In alveoles, MgSO₄ forms rigid sandloaden crusts which may peel off like stone sheets.

The lower right part of the outcrop (figure 5) is *not affected by any apparent weathering*. This area is not exposed to direct rain, nor is it reached by waters seeping from above or beside.

The origin of the sulfur in the outcrop studied is mainly related to the marl beds (marked in figure 5b) which contain up to 4% sulfur. Rust stains on the surface of the marls are often covered by a gypsum halo which indicates an oxidation of iron sulfides. The sandstone contains abundant dolomite which can react with the sulphate waters to form MgSO_4 and gypsum as stated by Pellerin ¹⁶.

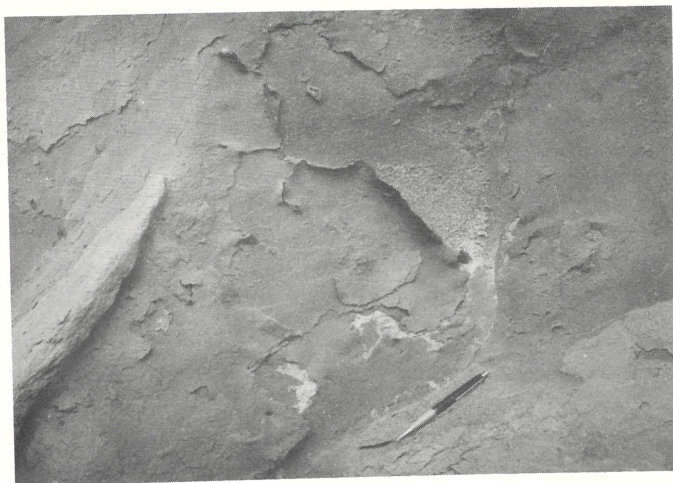
Fig. 7 – Detail in a peeling area. To the left, an edge resists disintegration. In the lower and right centre, peeling off stone sheets reveal MgSO_4 efflorescences which crystallize underneath.

Peeling is the superficial loosening of 0.5-1 mm thick stone sheets which tend to blister and fall off (figure 6 and 7). The process is distinguished by continuous repetition combined with granular disaggregation on sheets and underlying stone surface. It typically forms parallel to the stone surface which commonly is perpendicular to the bedding in this outcrop. Peeling may be influenced by the bedding where the surface is more or less parallel to it: the stone then tends to exfoliate (page 95. As well, the combined effect of peeling and exfoliation is most characteristic of Platten sandstones on buildings). Two to three sheets lying one upon another and blistering at the same time are common. The stone surface underneath the peeling sheets is covered with efflorescences (page 101).

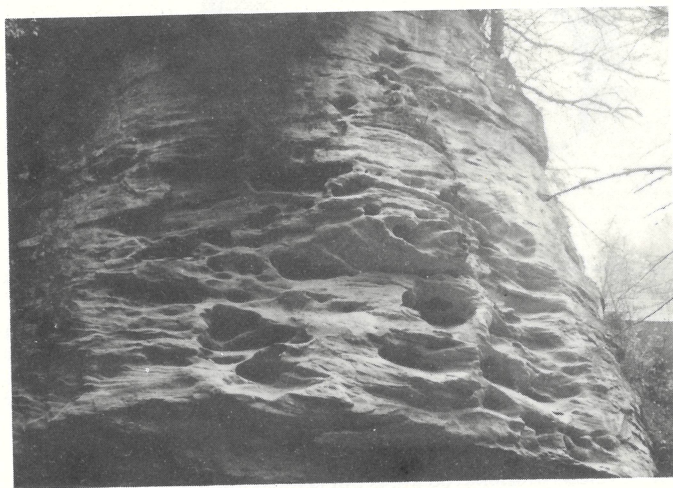
Fig. 8 – Platten sandstone affected by alveolation (Martinstobel, south from bridge in Martinsbrugg). On the south facing rock, alveoles in the order of some dm to more than 1 m have formed in parts sheltered from direct rain.

as wide. (An ample literature on this phenomenon offers several terms such as shadow and cavernous weathering, tafonisation, honeycombing, etc., compiled by Evans ⁷). In the outcrop shown in figure 5, a 20 cm deep alveole has formed among some blurred and smaller ones. On a neighbouring outcrop, a 100 m² large area is affected by alveolation. Large hollows in the order of some dm to more than 1 m can overlap a finemeshed pattern of a few cm large holes (figure 8).
